# Otter Creek *E. coli* and Geochemistry Analysis

Group Project from ISU ENVI 460: Conservation and Sustainability

Independent Research with Carlos Montanez and James H. Speer

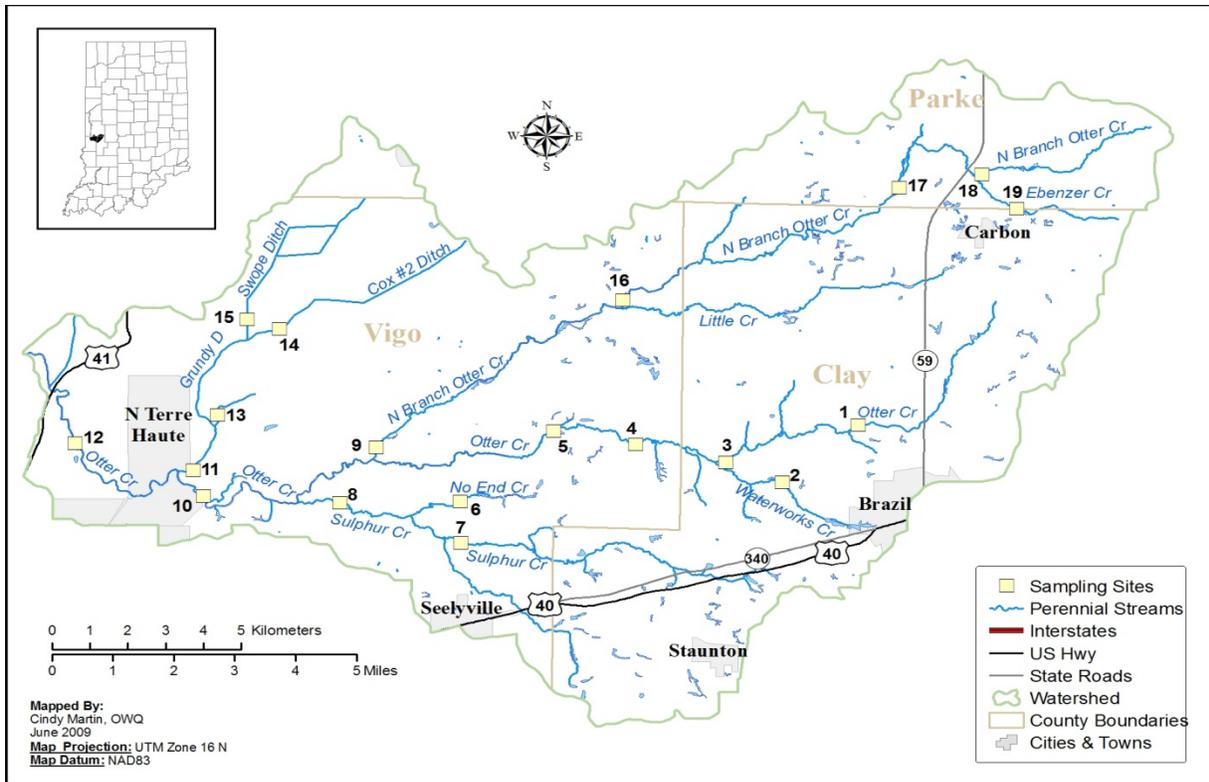
Figure 1: The Otter Creek Watershed including all of its named branches and the IDEM sampling locations (map created by Cindy Martin 2009).

The Otter Creek Watershed includes 220 miles of stream and drains 124 square miles (IDEM 2014). The watershed includes portions of Clay, Parke, and Vigo county and includes parts of the following cities: North Terre Haute, Seelyville, Staunton, Brazil, and Carbon (Figure 1). The land in the watershed is mainly a mixture of forest and agriculture or pastureland that includes many head of cattle, horses, pigs, and sheep (Figure 2).

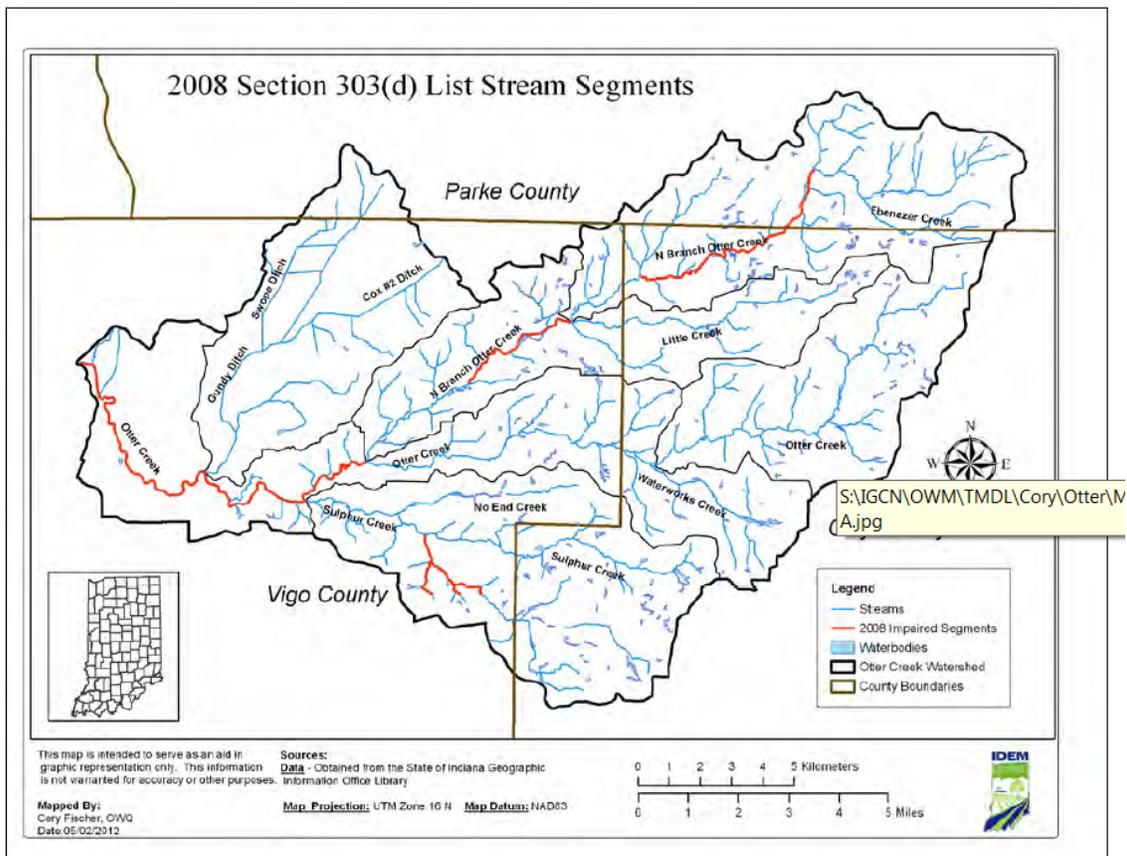
Figure 3: Streams listed on the 2008 Section 303(d) list in the Otter Creek Watershed of impaired stretched of Otter Creek from the IDEM 2014 TMDL Report.

IDEM has surveyed the streams in the Otter Creek Watershed in 2008 (Figure 3) and again in 2014 (Figure 4) for *E. coli* contamination and found a great increase from a few stretches of contamination in the stream to almost every stretch showing presence of *E. coli* (IDEM 2014). This Total Maximum Daily Load report from IDEM has raised enough concern about the watershed that a community group called the Ouabache Land Conservancy has brought together a group community organizations and individuals to apply for an IDEM 319 grant that was submitted in September 2015. The work that is reported on here was completed in an Indiana State University ENVI 460: Conservation and Sustainability course and later followed up with an independent research project from Carlos Montanez under the supervision of Dr. James H. Speer.

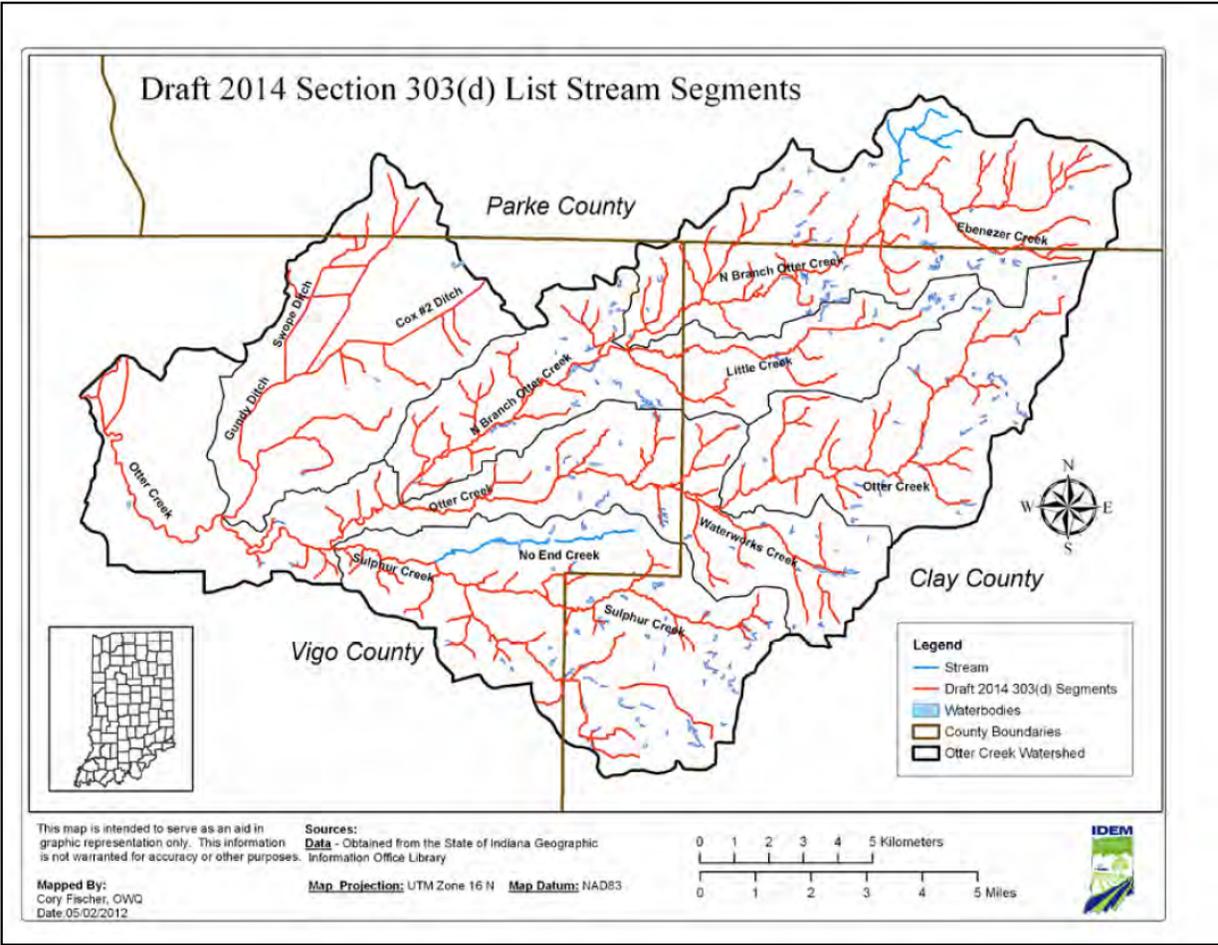
Figure 4: Streams listed on the 2014 Section 303(d) list in the Otter Creek Watershed of impaired stretched of Otter Creek from the IDEM 2014 TMDL Report.

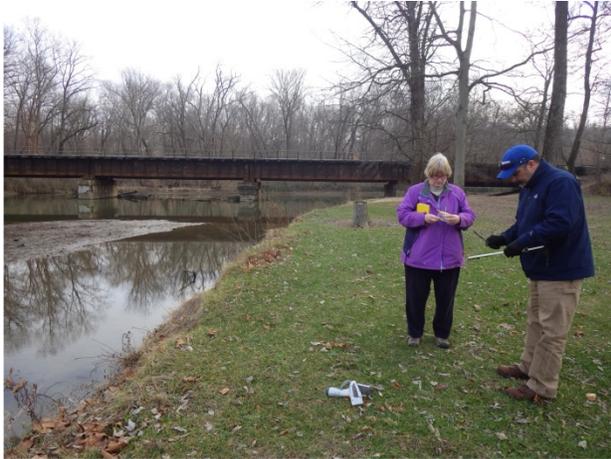
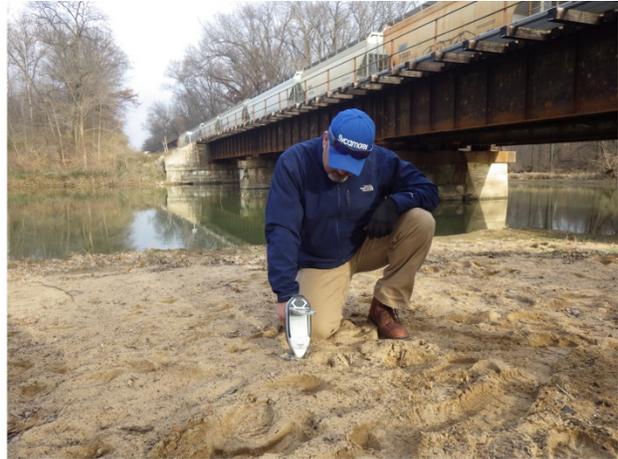
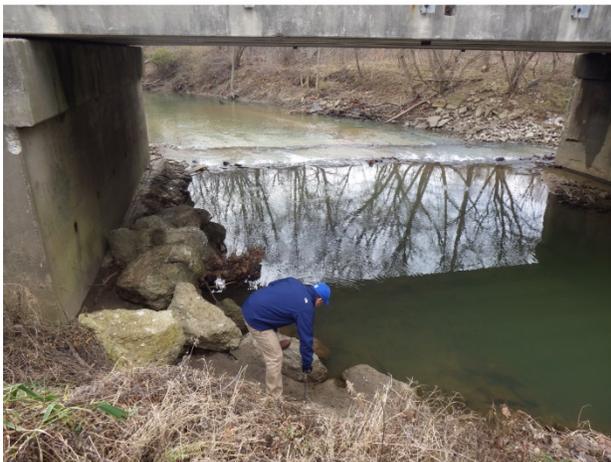
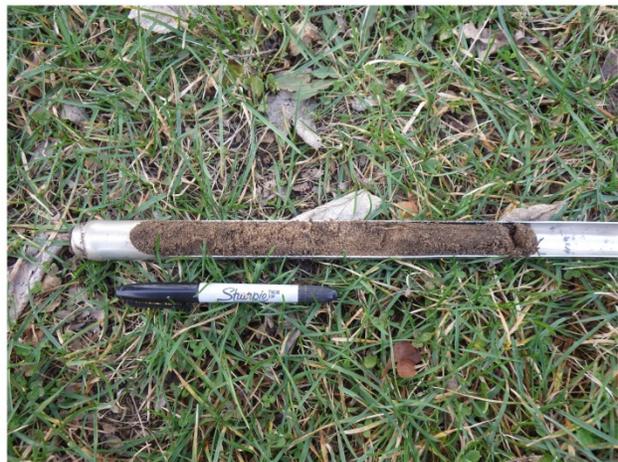
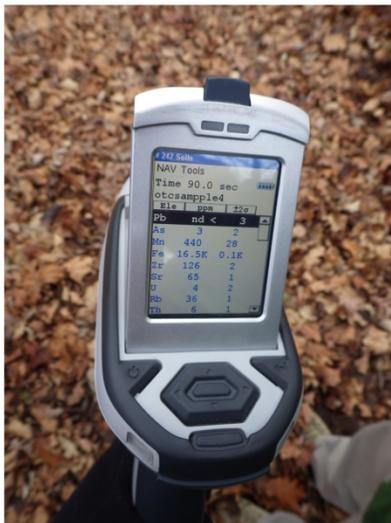
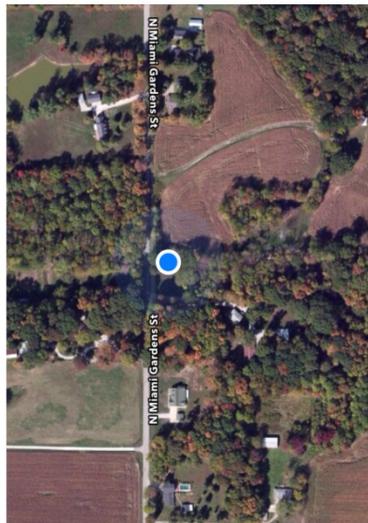
Figure 5: We took samples with a soil auger, collected the top three inches in a whirl-pak bag and measured the elemental concentration through the bag with the XRF.

We also collected six soil samples from the same locations as the water samples, but along the bank of the creek. We placed the samples in whirl-paks and used x-ray fluorescence (XRF) to test the heavy metals levels in each of the samples through the film of the bag. We compared these levels with the levels that are currently deemed as safe for each of the metal components. In December 2015, we collected four more sediment samples for XRF analysis and completed a dashboard survey of the watershed starting at Mill Pond and driving through back roads along branches of the creek back to the location where the North Branch of Otter Creek crosses Hwy 59 north of Carbon, Indiana (Figure 5).

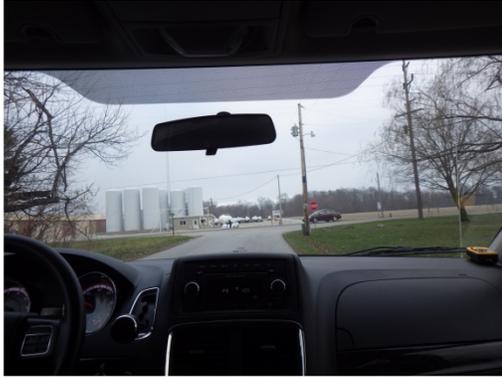
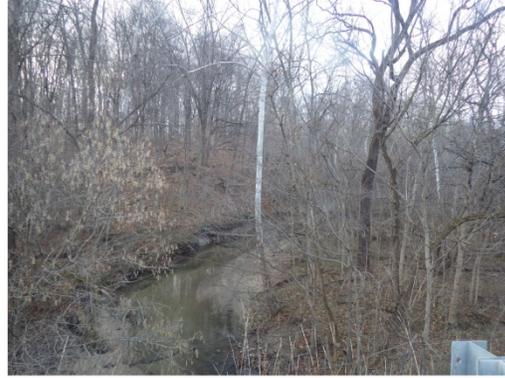
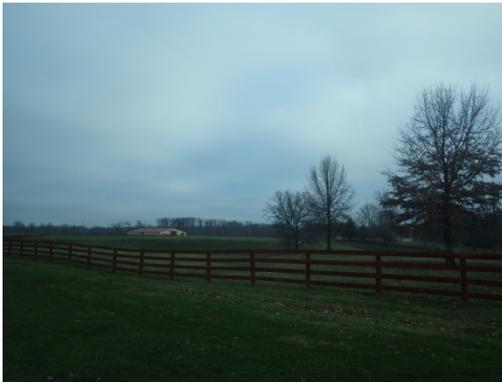
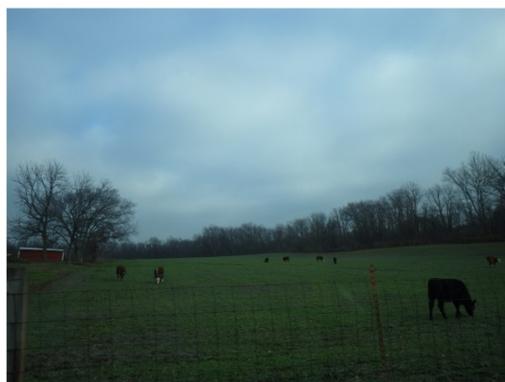
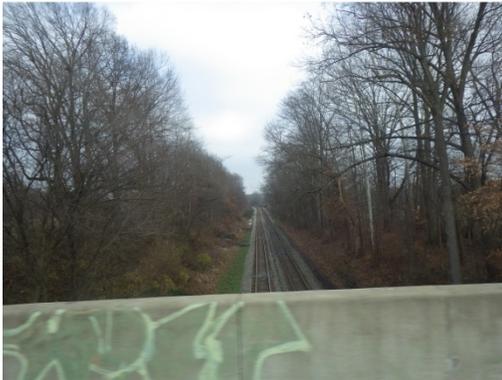
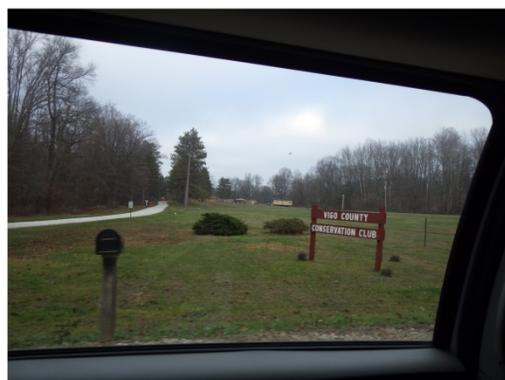
Figure 6: Images from our dashboard tour on December 4<sup>th</sup>, 2015. We observed a fairly stable watershed with much forested land and agriculture. We also saw many head of cattle, horses, and miniature horses, although the densities were not very high.

During our dashboard survey of the area, we observed much forest area around the streams and extensive agricultural land as well (Figure 6). Many plots of land had livestock such as cattle, horses, miniature horses, and sheep. The density of animals was never observed to be very high. A railroad crosses through the area and a conservation club is located in the middle of the watershed.

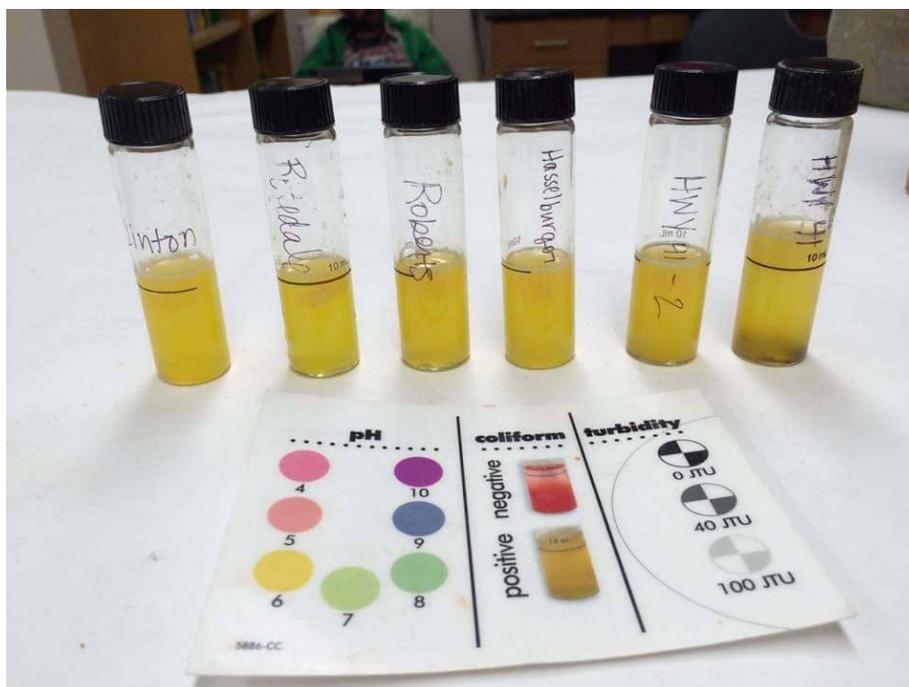
Figure 7: Each of the six sites tested positive for *E. coli* as represented by their yellow color. The pattern of elemental concentrations was consistent across the sites with relatively high levels of Iron, Manganese, Zircon, Strontium, Zinc, and Rubidium (Figure 6). Most of the levels were below the EPA Critical Continuous Concentration and Critical Maximum Concentration levels suggesting that the elemental concentrations in Otter Creek are safe for aquatic life.

Each of the six water samples were bright yellow, meaning they were positive for *E. coli* (Figure 7). *E. coli* has been found to be present in almost all of the stretches of Otter Creek in the IDEM 2014 report and we were able confirm that result with the presence of *E. coli* at each of our test sites in April 2015.

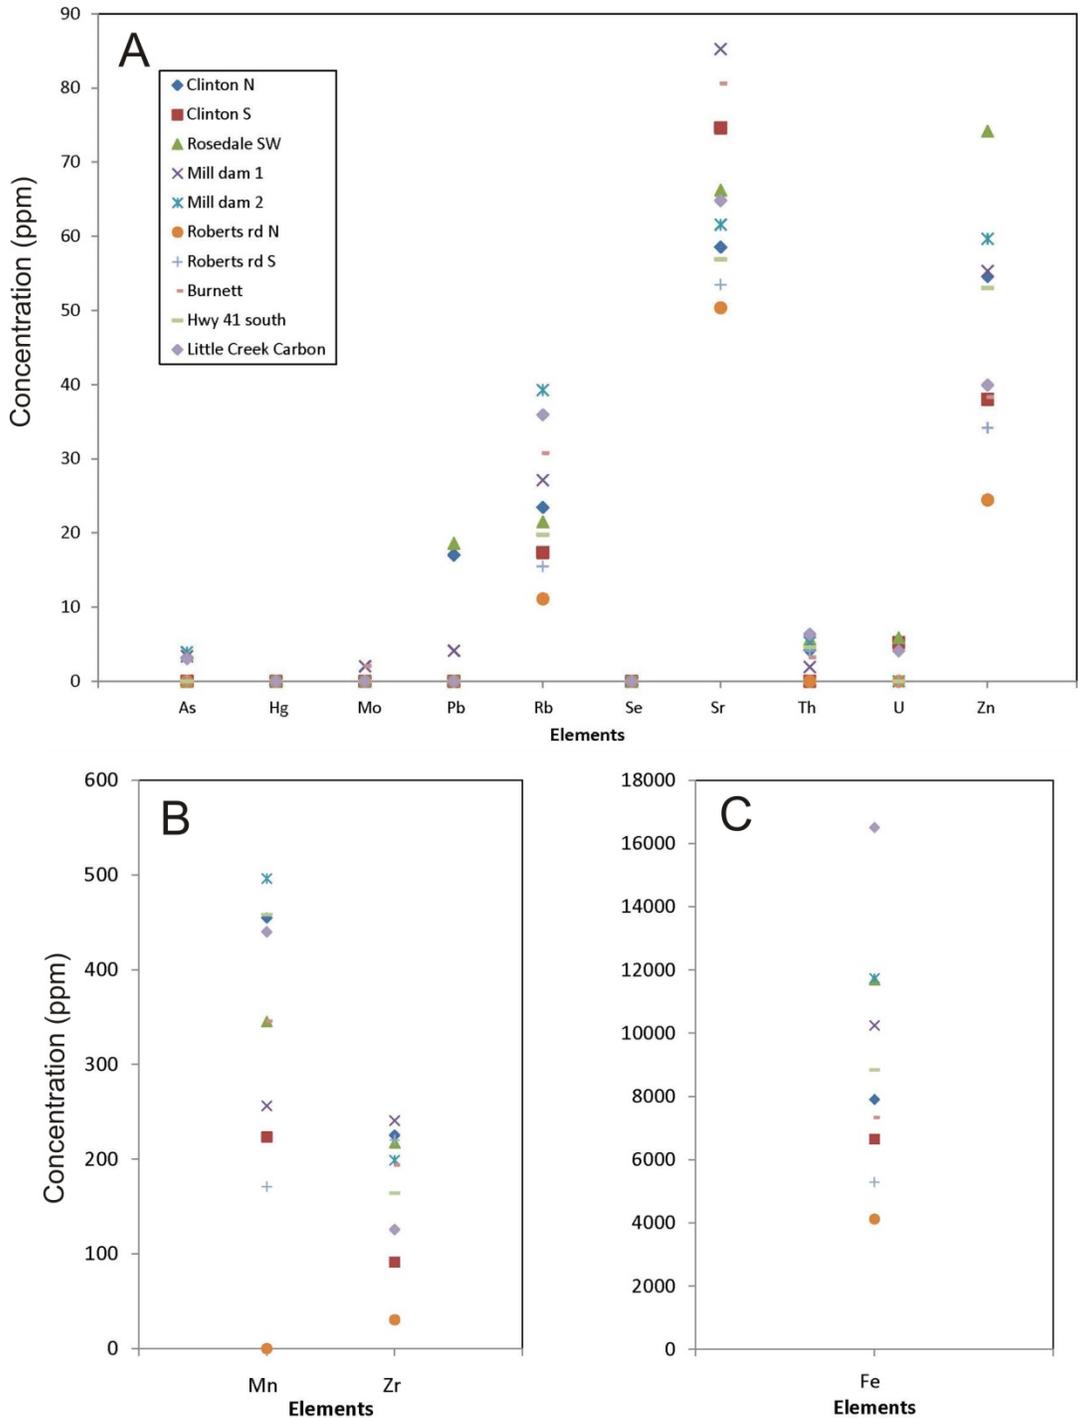
Figure 8: Elemental concentrations in the sediment along Otter Creek collected at road crossings of the different branches of the creek. Sites are organized from west (downstream – top) to east (upstream – bottom). Samples were collected in April 2015 and December. A shows the main suite of elements and the other charts B (Mn and Zn) and C (Fe) were drawn with a different vertical axis because of the values for each element.

XRF samples were taken at 10 locations between the two sample expeditions. These samples were clumped together for the analysis in this paper. Concentrations were relatively higher for iron, zircon, manganese, strontium, zinc, and rubidium (Figure 8). None of the individual sample sites stood out from the others as being consistently higher than the others and concentrations did not seem to increase as we moved downstream.

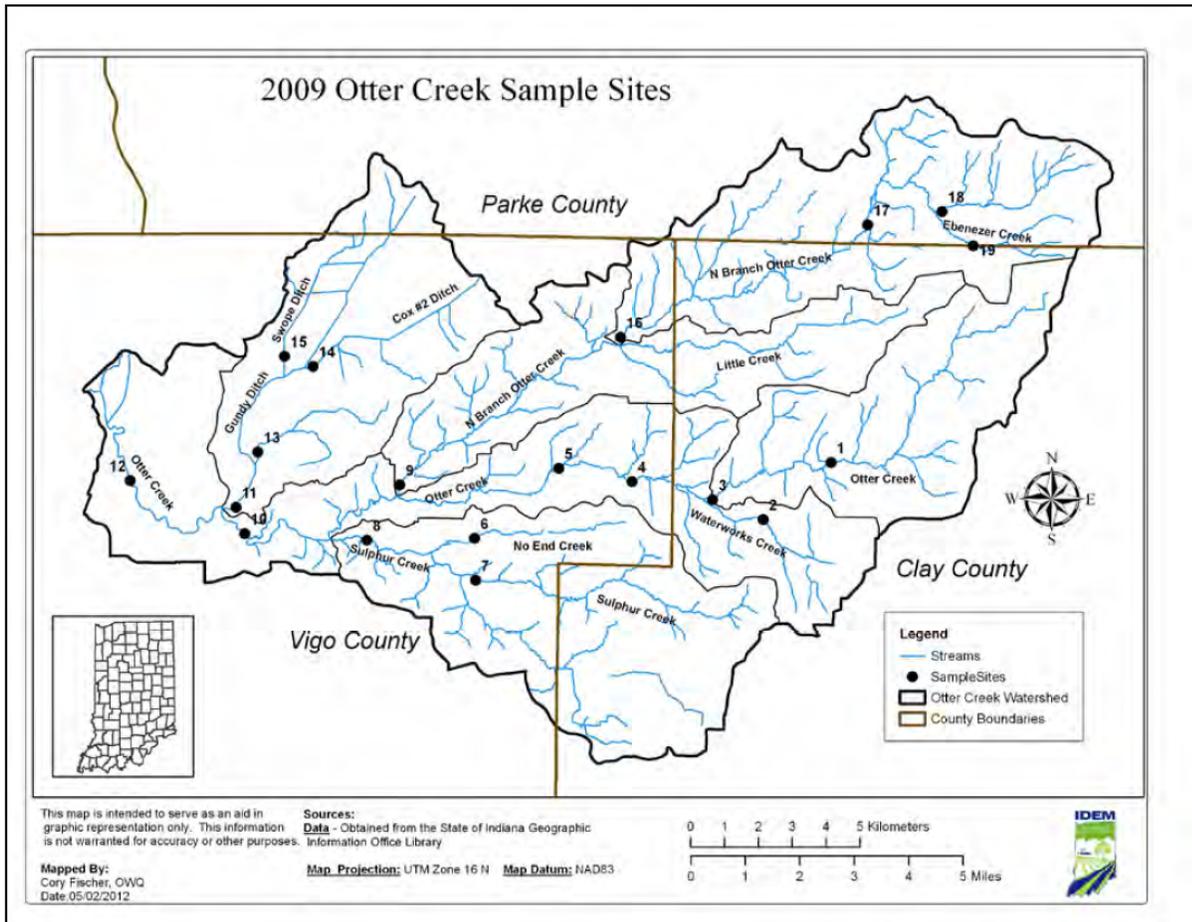
**Figure 3. Sampling Locations in 2009 Otter Creek Watershed TMDL**  
 From the IDEM 2013 TMDL Report

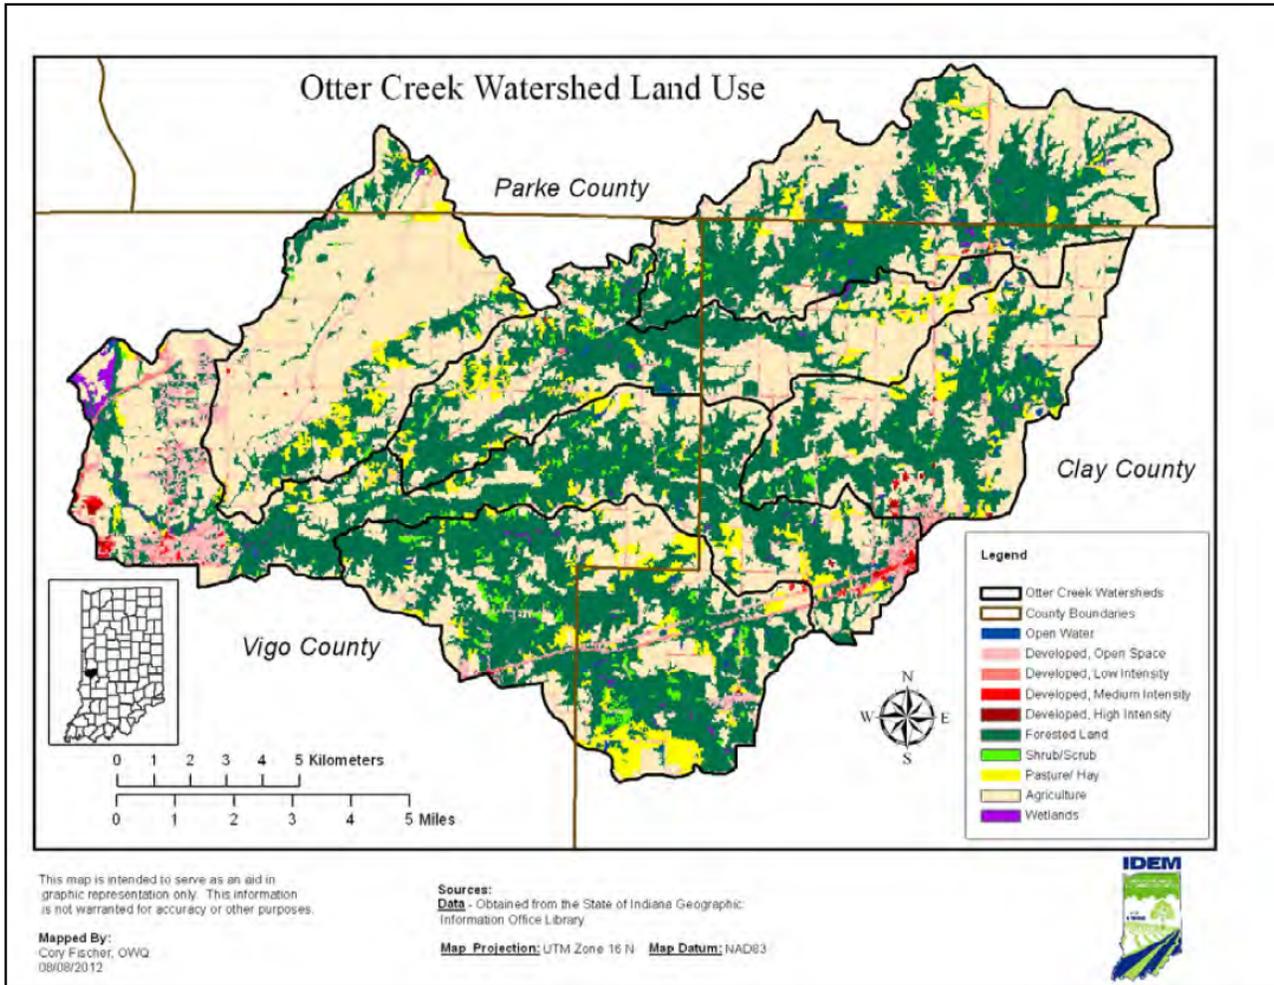
**Figure 6. Land Use in the Otter Creek Watershed**

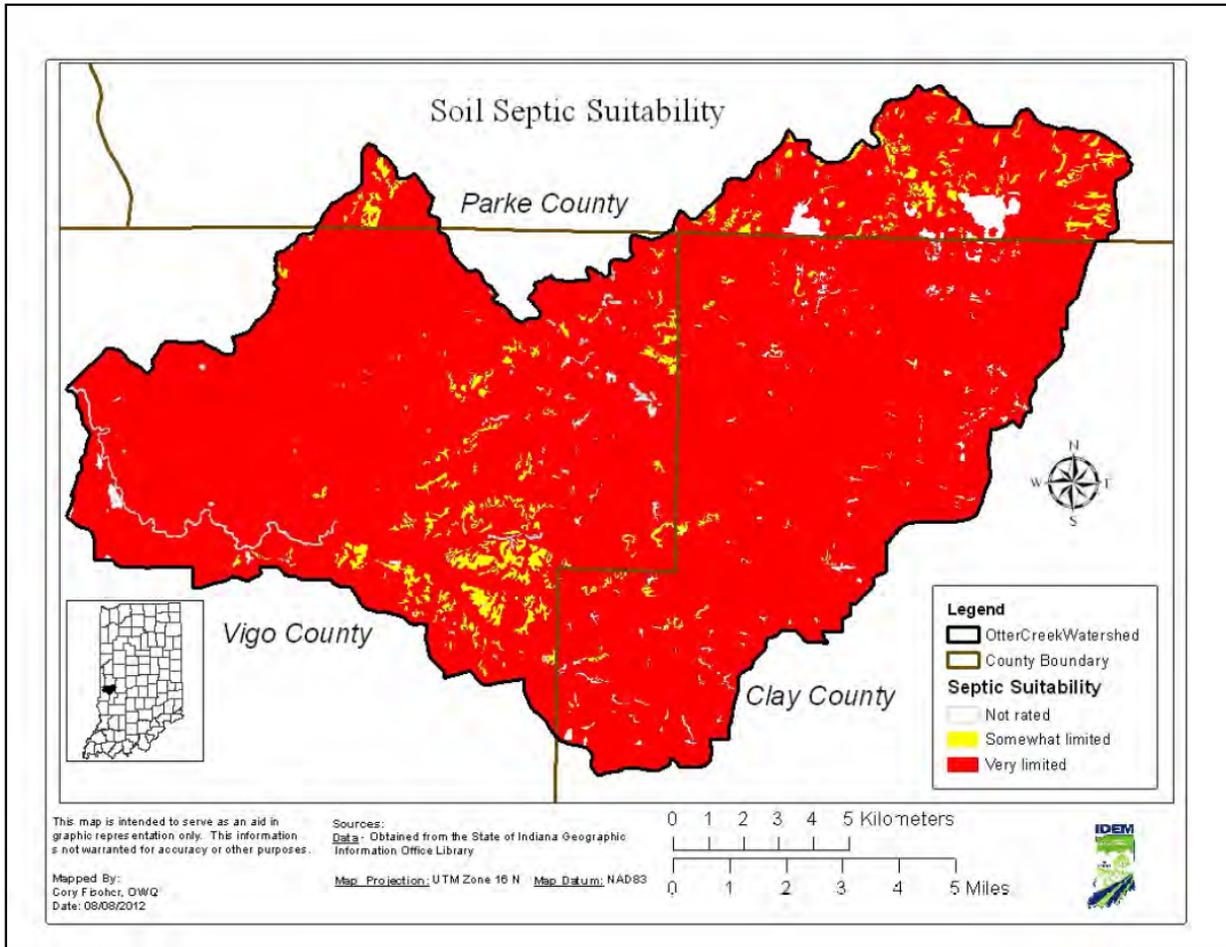
**Figure 11. Suitability of Soils for Septic Systems in the Otter Creek Watershed**

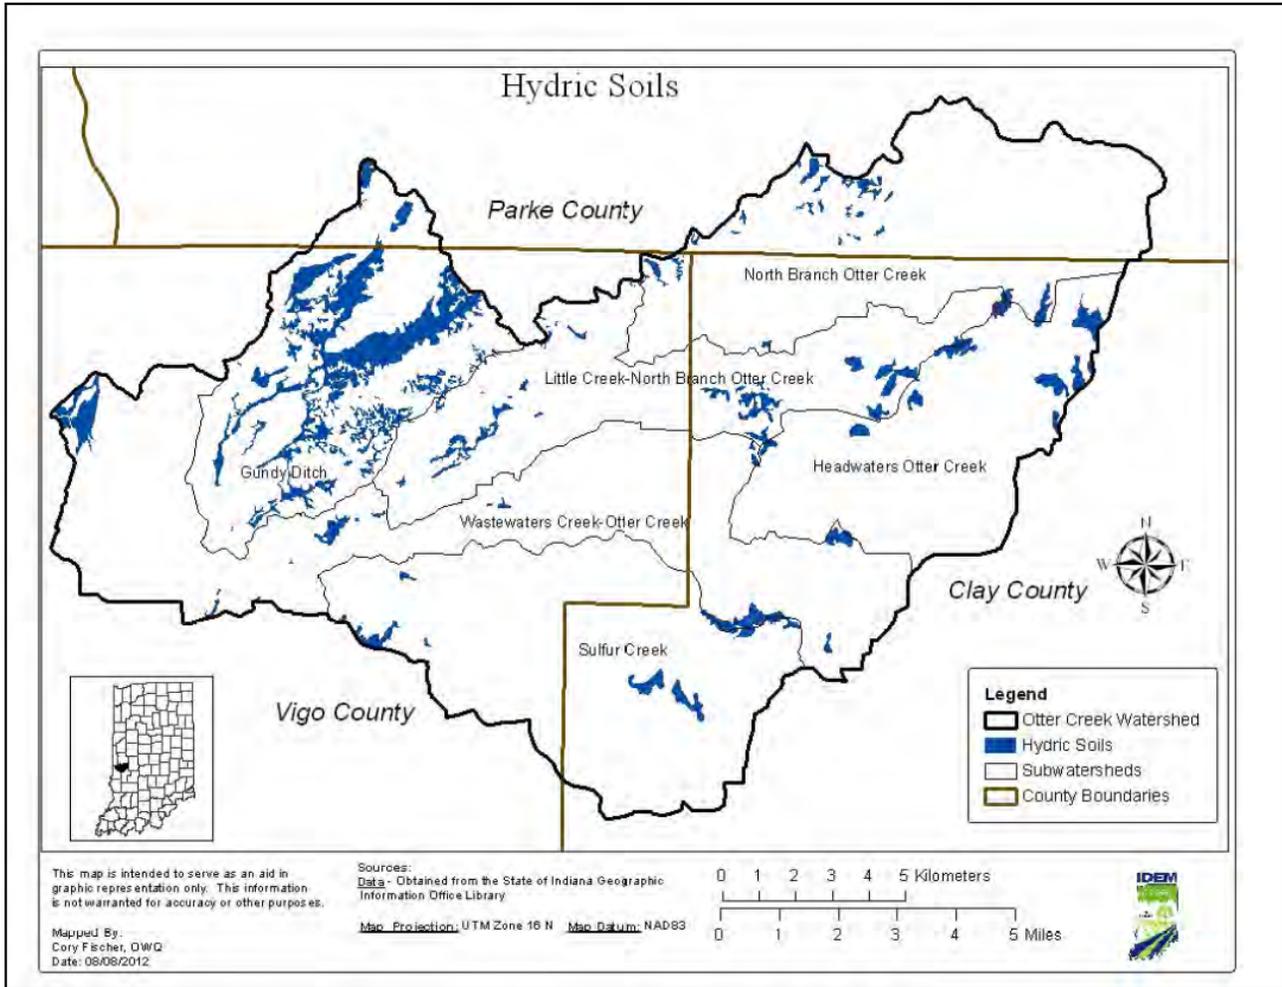
**Figure 12. Hydric Soils in the Otter Creek Watershed**

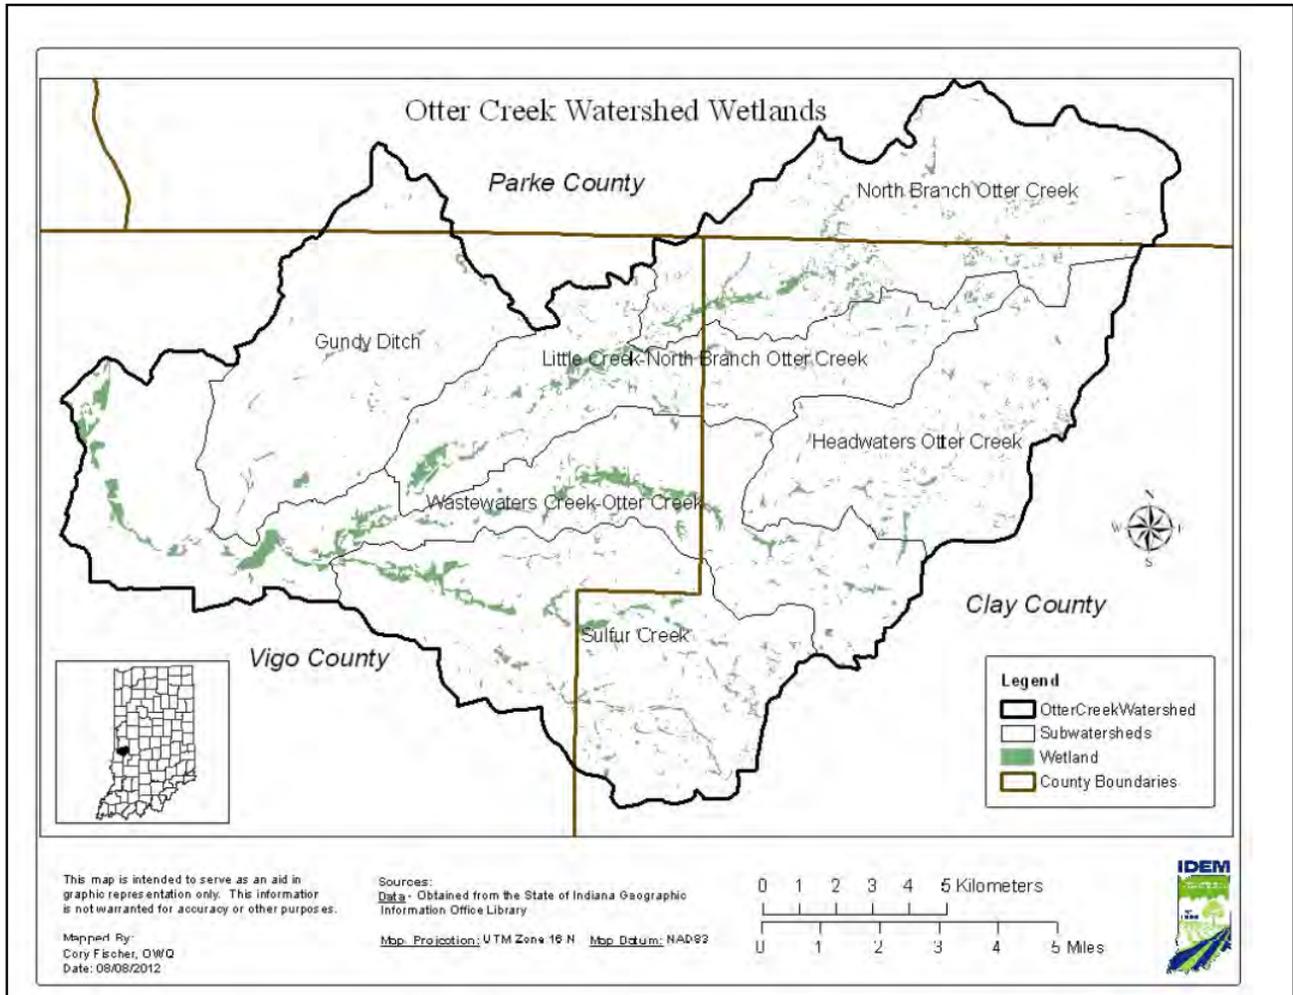
**Figure 13. Wetlands in Otter Creek Watershed**

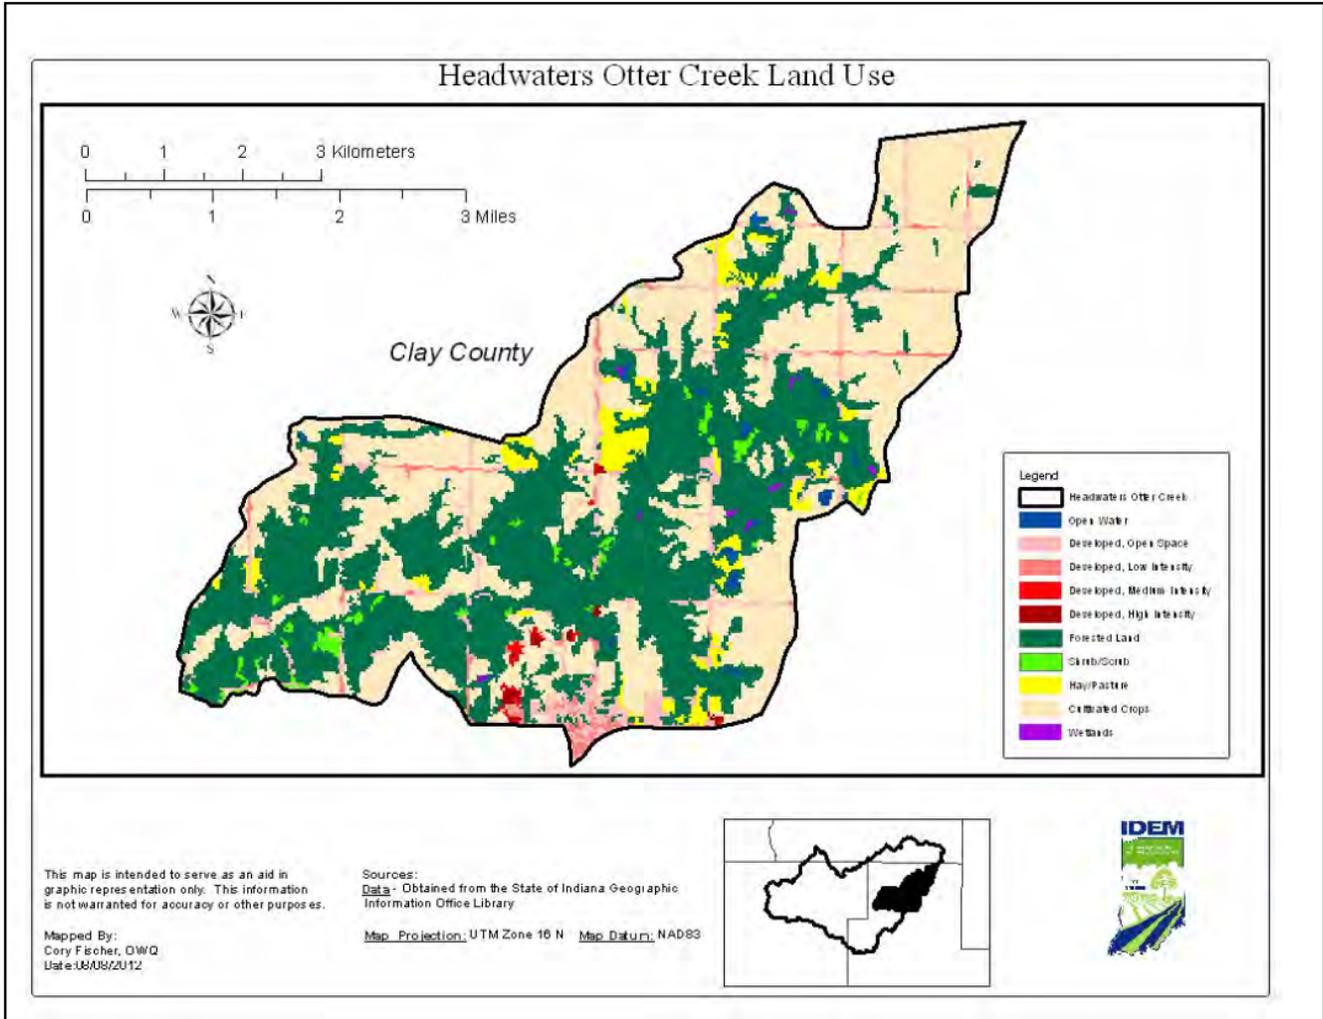
**Figure 15. Land Use in the Headwaters Otter Creek Subwatershed**
